Re: Shelman Trail Sub-Grade Testing

## SHELMAN TRAIL SUB-GRADE TESTING

**PURPOSE:** The purpose of the sub-grade testing performed on December 15, 2009 was to evaluate the condition of a sub-grade placed in March of 2009 and treated with Roadbond en1.

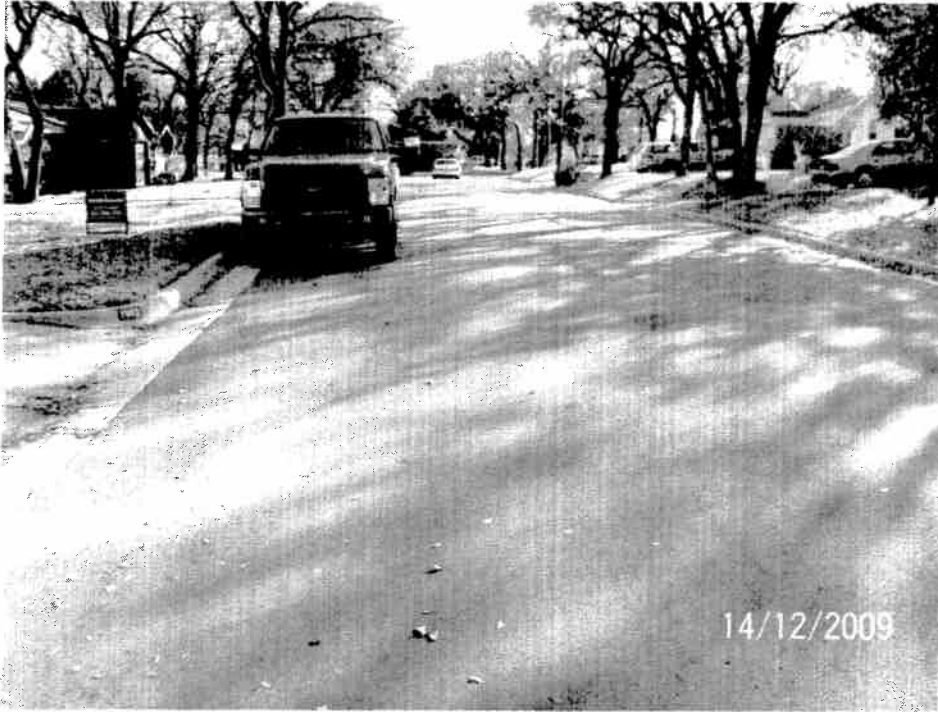
The current condition of the test section is excellent. There are a few very fine cracks in the area of the trees which are too fine to rout and seal. These very fine cracks were apparently caused by clay shrinkage due to water demand by the tree roots. Outside the area of the trees, the condition of the test section is near perfect (See picture #1 & #4). There is no rutting or stress cracking anywhere in the test section.

Picture #1-Roadbond en1 treated area-Near perfect condition.

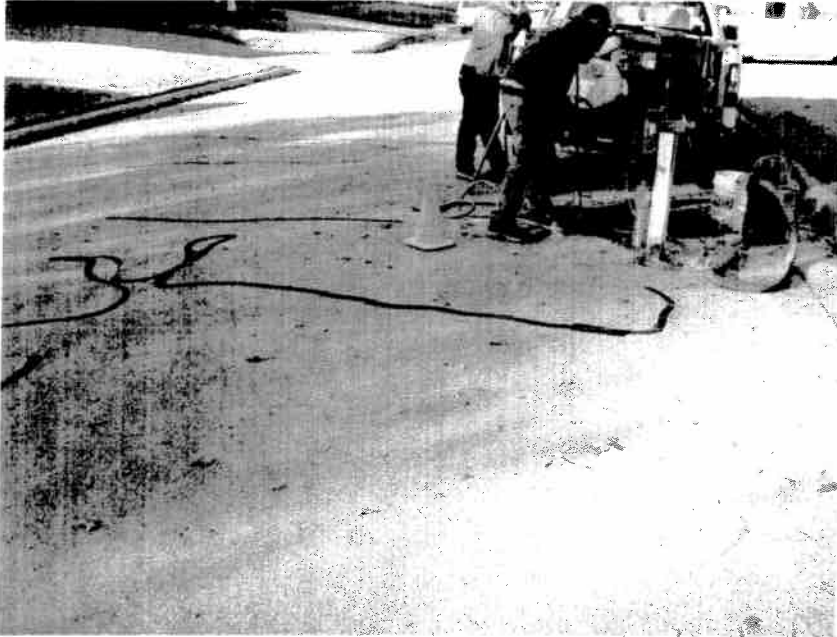
Picture #2-Sample taken from untreated area-recently crack sealed with asphalt.

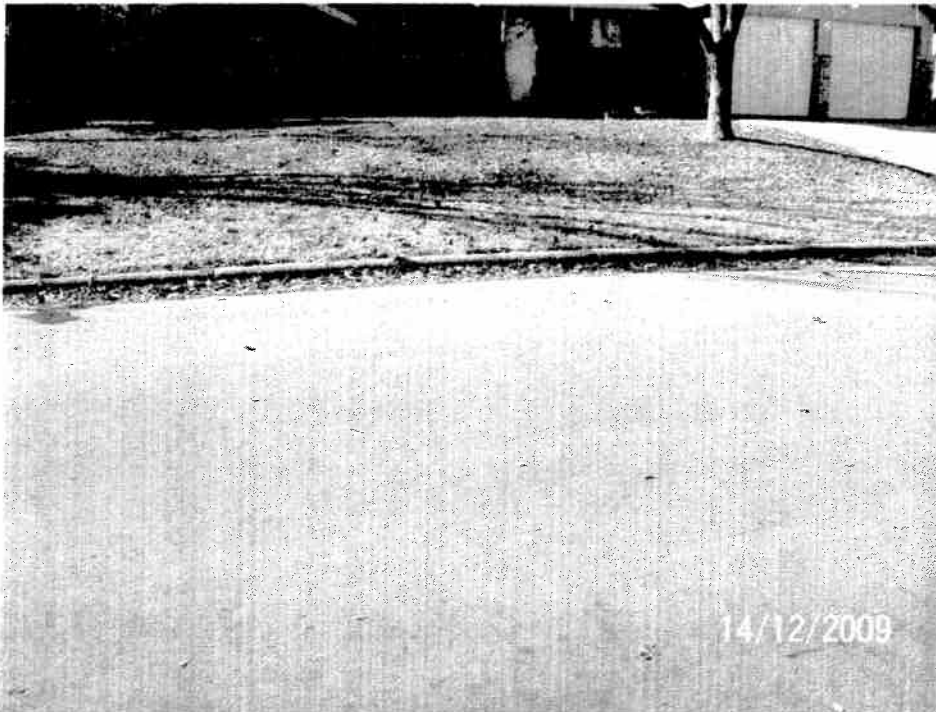
The asphalt at location K-3 (1908 Shelman Trail), outside the wooded area, was 2.5 inches thick. The blow count on the base course was forty-four (44). That is equivalent to approximately 13,000 psf. The blow count on the second layer was 26 blows (9500 psf), but dropped sharply to 4 blows in the third layer which was untreated and contained no aggregate. The four blow reading in the untreated soil is equivalent to about 3000 psf, the lowest value available for input into the WINPAS street design program for sub-grade. This compares to other tested locations in similar soils. The moisture levels in the base course material averaged 10%. The moisture level in the 12" to 18" level was 17.9%.

Picture #4-K-3 location-Blow count was 44. No trees in this area.
