CITY OF FT. WORTH, TEXAS BLOCK CRACKS

Summary of the Ft. Worth Sites

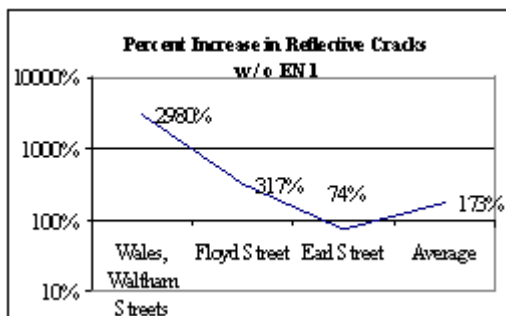
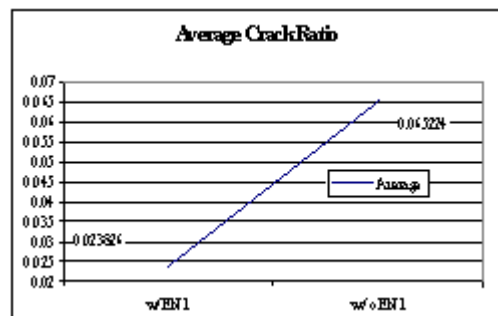
A total of 70,005 square feet of **ROADBOND EN 1** and 50% rates of Portland cement was installed over the three projects compared to 122,730 square feet of control. While no repairs were made to the **ROADBOND EN 1** sections, significant repairs were made to the control sections. The average crack ratio for the treated sections was 2.4% compared to a crack ratio of 6.5% for the control sections. The use of Portland cement alone resulted in 174% more reflective cracks on average and more failures and repairs than a combination of Portland cement and **ROADBOND EN 1**.

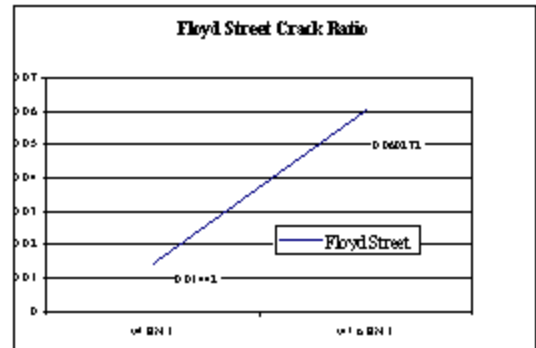
Floyd Street

J.L. Bertram Construction Co. in October 1996 installed Floyd Road. The 3600 block was the trial section, while the 3700, 3800 and 3900 blocks were the control sections. Both sections were paved with an asphalt overlay. The treated section consisted of 6,864 square feet and 28 months after construction had 99 linear feet of cracks with no repaired cracks or patched failures. This resulted in a crack ratio of .01442.

The control section consisted of 67,267 square feet and began to display distress just a few months after construction. Just 28 months after construction the control section had 3,938 feet of cracks with 135 feet having been patched. The section also contained 1,930 square feet of patched base failures. The crack ratio of this section was .060272 or a 317% increase over the **ROADBOND EN 1** section.

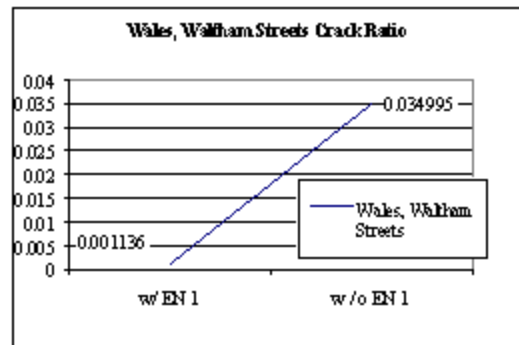
Wales Street, Block 5400-5500

Ed Wilson Construction Company in November 1997 installed Wales Street. Wales Street was the trial section while Waltham Street was the control. Both sections were paved with concrete. The treated section consisted of 46,648 square feet and 15 months after construction had 53 feet of reflective cracks. None of the cracks had been patched. The crack ratio was .001136.

The control section consisted of 40,920 square feet and had 1,230 linear feet of cracks of which 202 feet of the linear cracks had been repaired. The crack ratio was .03499 or a 2,980% increase over the **ROADBOND EN 1** treated section

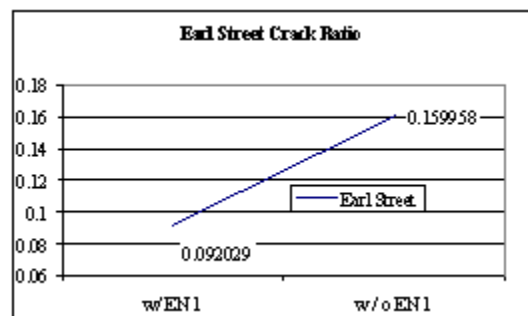
The Ft. Worth city street crew in early 1998 installed Earl Street. The street was divided in half with the east half being the trial section while the west half is the control section. A fire hydrant on the south side of the street is the demarcation line. Both sections consist of 16,473 square feet with an asphalt overlay.

The treated section had 1,516 linear feet of cracks and a crack ratio of .092, whereas the control section had 2,635 linear feet of cracks and a crack ratio of .1599. That is a 74% increase in cracks over the **ROADBOND EN 1** section.

The graph illustrates the reduction in block cracks resulting from the **ROADBOND EN 1** at 12 months and 6 years after construction. After 6 years the section without **ROADBOND EN 1** had more than twice as many block cracks!
