REDUCE BLOCK CRACKS WITH ROADBOND EN 1

Roadbond EN 1 enhances the effectiveness of Portland cement so that the design strength can be achieved using 40% to 50% less conventional stabilizer. The benefits are:

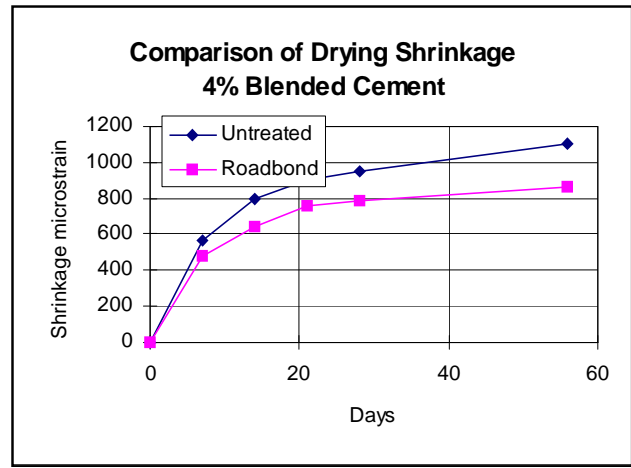
The graph to the right is compiled using data obtained from lab tests conducted by the **Department of Transport *South Australia***. Block cracks were evaluated on 4% Portland cement with and without Roadbond EN 1. Block cracks were considerably less when Roadbond EN 1 was utilized.

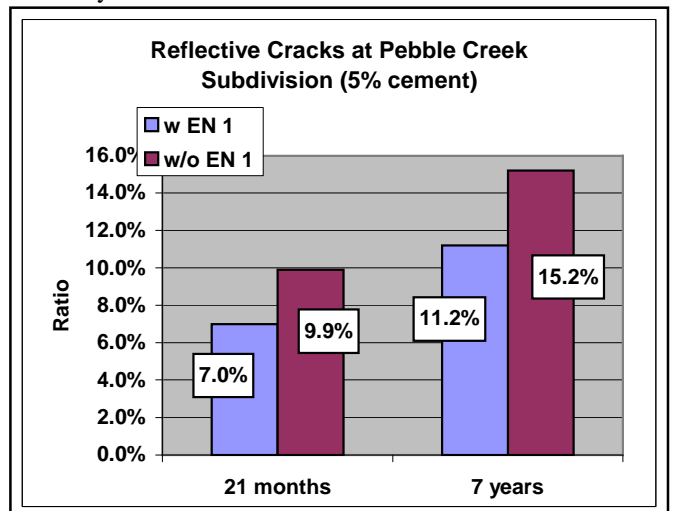
The block cracks were measured and compared at 21 months and again after 7 years. The graph illustrates the effectiveness of Roadbond EN 1 in reducing block cracks in Portland cement-stabilized material.

The trial site is 800 Coral Ridge, a cul-de-sac off of St. Andrews Street and is 11,986 SF. Roadbond EN 1 and 21 pounds of Portland cement (5%) was mixed into the base material, compacted and shaped to grade, then paved with an asphalt overlay.

which is the cul-de-sac across St. Andrews from the trial section and is 11,356 SF. The construction method and Portland cement rates (5%) were the same as the trial section with the only change being that water was used instead of the Roadbond EN 1 solution to process the material.

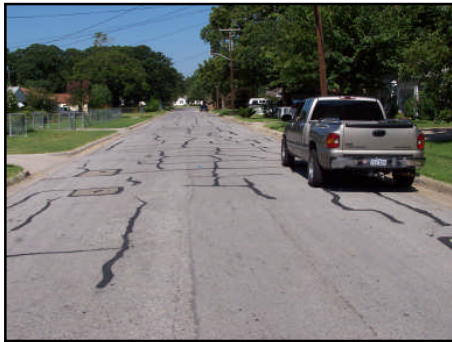
City of Ft. Worth Earl Street

In 1998, the City of Ft. Worth used 6% Portland cement and compared that to Roadbond EN 1 and 3% Portland cement. Earl Street was divided in half and a fire hydrant on the south side of the street is the demarcation line. Both sections consist of 16,473 square feet with

The graph illustrates the reduction in block cracks resulting from the Roadbond EN 1 at 12 months and 6 years after construction. After 6 years the section without Roadbond EN 1 had more than twice as many block cracks!

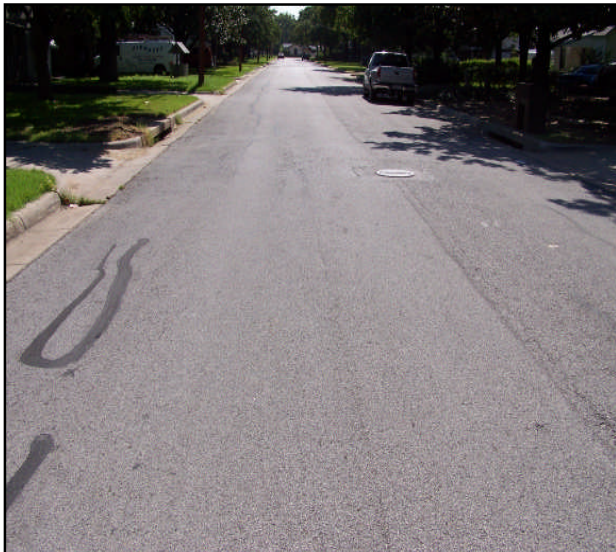
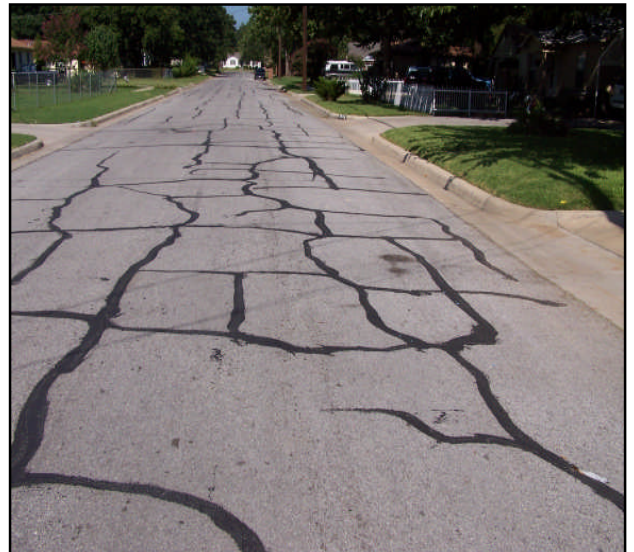
The photos clearly contrast the difference between the full rates of Portland cement and ½ rates of Portland cement and Roadbond EN 1.
